Docket No. 217 – Development and Management Plan Inspection

Northeast Utilities Service Company Certificate of Environmental Compatibility and Public Need for the construction of a 345-kV electric transmission line and reconstruction of an existing 115-kV electric transmission line between Connecticut Light and Power Company's Plumtree Substation in Bethel, through the towns of Redding, Weston, and Wilton, and to the Norwalk Substation in Norwalk, Connecticut.

Norwalk Substation

Date: July 5, 2006

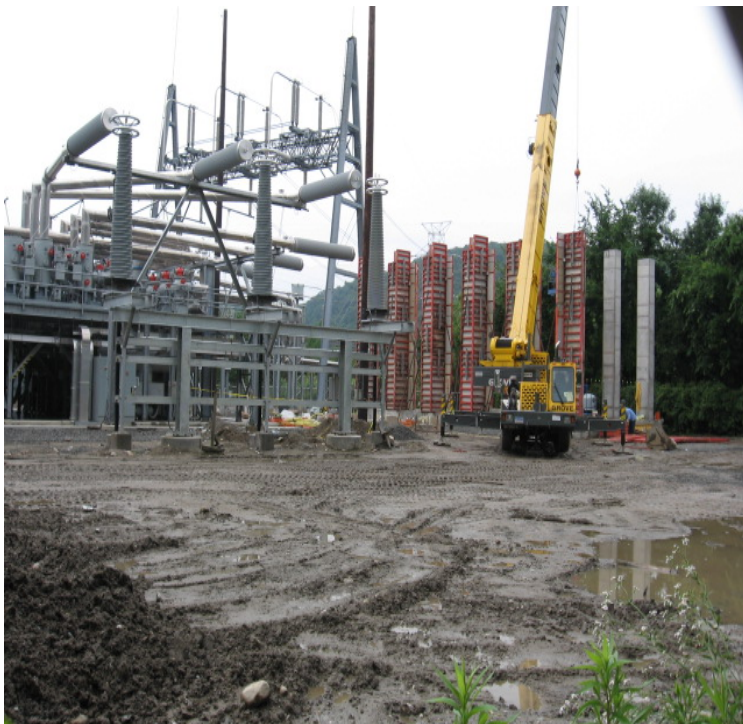
Plumtree Substation: Photo on the left shows where structure work continues in the yard. Photo on the right shows turbid water pooling in the access drive adjacent to the wetland. This has been flowing to the wetlands during rain events. This was likely occurring prior to any expansion work on site and not directly resulting from the project. 7/5/06

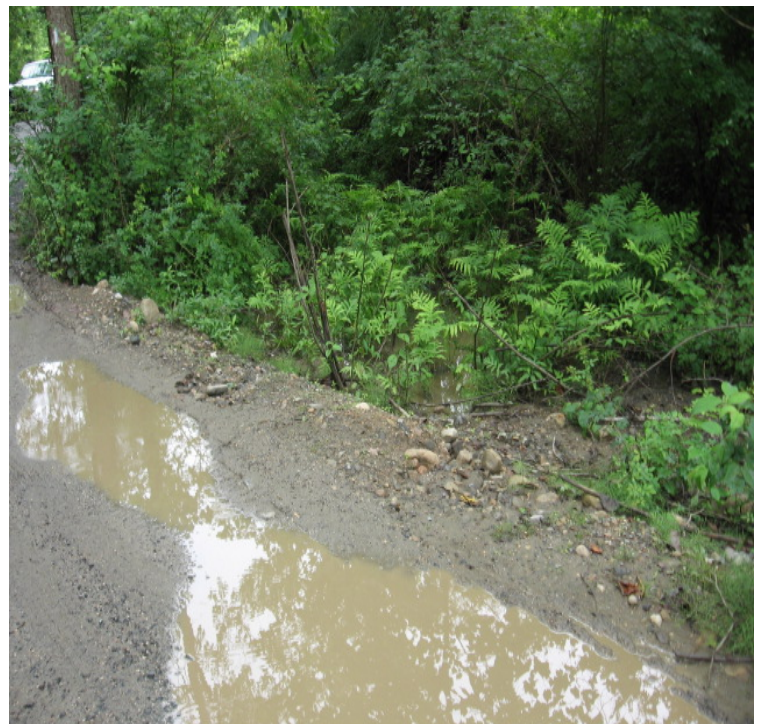
| Areas of Inspection | Observation | Recommended Action | Corrected Action |
|---|---|---|---|
| Access Roads | <ul style="list-style-type: none"> - Work has returned to the substation so the drive is again in use for this equipment. 7/5/06. -Turbid water was noted pooling in the access rd and it flows to the wetland swale 7/5/06 | <ul style="list-style-type: none"> - None at this time. 7/5/06. - This is likely a pre-existing condition and not directly related to the expansion work 7/5/06 | <ul style="list-style-type: none"> -N/A. - N/A |
